# Naval Research Laboratory

NRL/MR/7130--99-8324

## Sonar Dome Deflection Measurements on the USS RADFORD

June 2, 1999

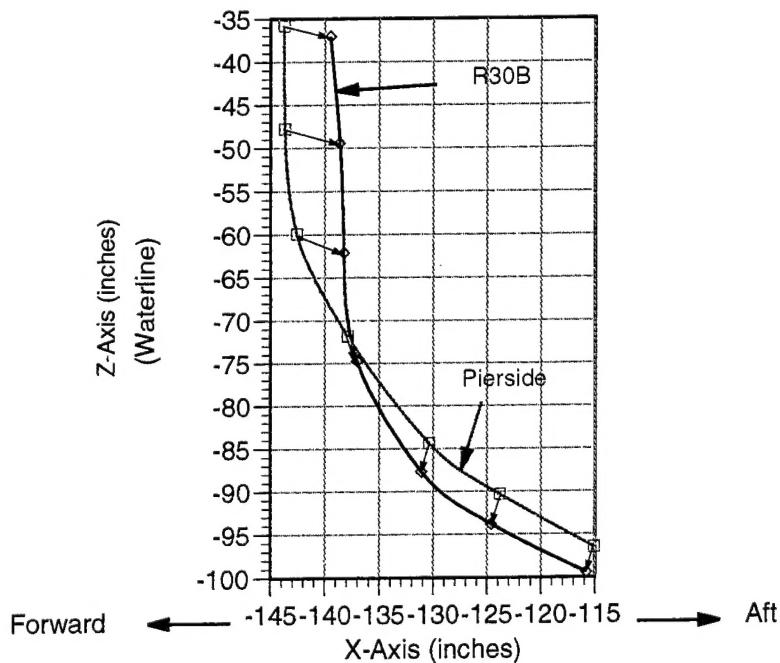
**Figure 1. USS Radford SDRW Centerline Cross Section**

(1) Centerline deformation was consistent with previous measurements, but larger in amplitude (maximum deformation observed was 5.27 inches at 31 knots). The deformation behavior of the centerline for the highest speed run (R30B at 31 knots) is shown in Figure 1. This shows that due to the force of the seaway, the upper part of the dome is displaced inwards (towards the sonar array), and the lower part bulges outwards.

Data Run: R30B Speed: ~31kts Sea State: 3

(2) Figure 1 also shows that the entire front section of the sonar dome was displaced downwards, with the largest downward displacement in the lower region.

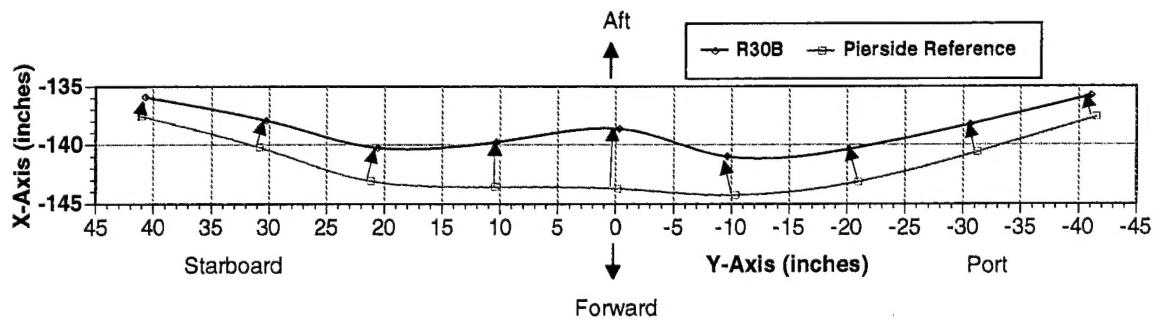
Figure 2. USS Radford SDRW -4ft Waterline Cross Sectional View  
About the Centerline  
Data Run: R30B Speed: ~31kts Sea State: 3

(3) Figure 2 shows the -4 foot waterline deformation for the same data run at 31 knots.

(4) A depression was observed (at high speed) around the upper centerline (for approximately 20 inches). This feature can be clearly seen in Figure 2 and also in the contour plot of Figure 3.

**Figure 2** shows the -4 foot waterline deformation for the same data run at 31 knots. A depression is observed (particularly at high speed) for approximately 20 inches around the upper centerline. This feature can also be clearly seen in the contour plot of **Figure 3**. The inward deformation of the upper front part of the dome (shown in magenta) is compensated by the outward deformation of the lower front and the slight outward deformation of the sides of the dome (shown in cyan). There is an overall downward deformation of the entire dome (seen in the second plot in **Figure 3**), with the front of the dome experiencing the largest shift downwards. This shows that the downward displacement noted above in item (2) for the front part of the dome applies globally to the entire sonar dome.

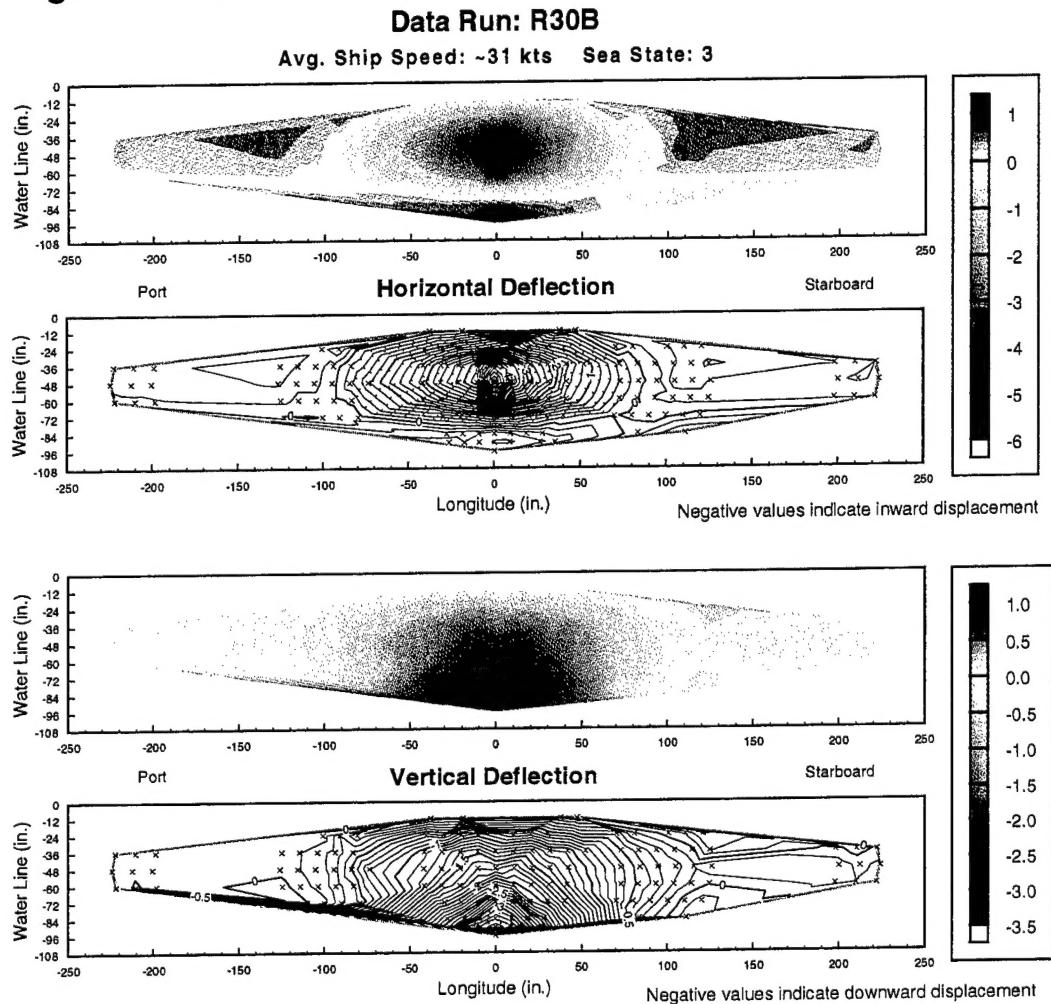
**Figure 3: USS Radford SDRW Deflection Color Contour Plots**

(5) The inward deformation of the upper front part of the dome (shown in magenta in Figure 3) is compensated by the outward deformation of the lower front and the slight outward deformation of the sides of the dome (shown in cyan). The incompressibility of the water filled sonar dome requires that any deformations be such as to conserve the total volume.

(6) There is an overall downward deformation of the entire dome (seen in the second plot in Figure 3), with the front of the dome experiencing the largest shift downwards. This shows that the downward displacement noted above in item (2) for the front part of the dome applies globally to the entire sonar dome.

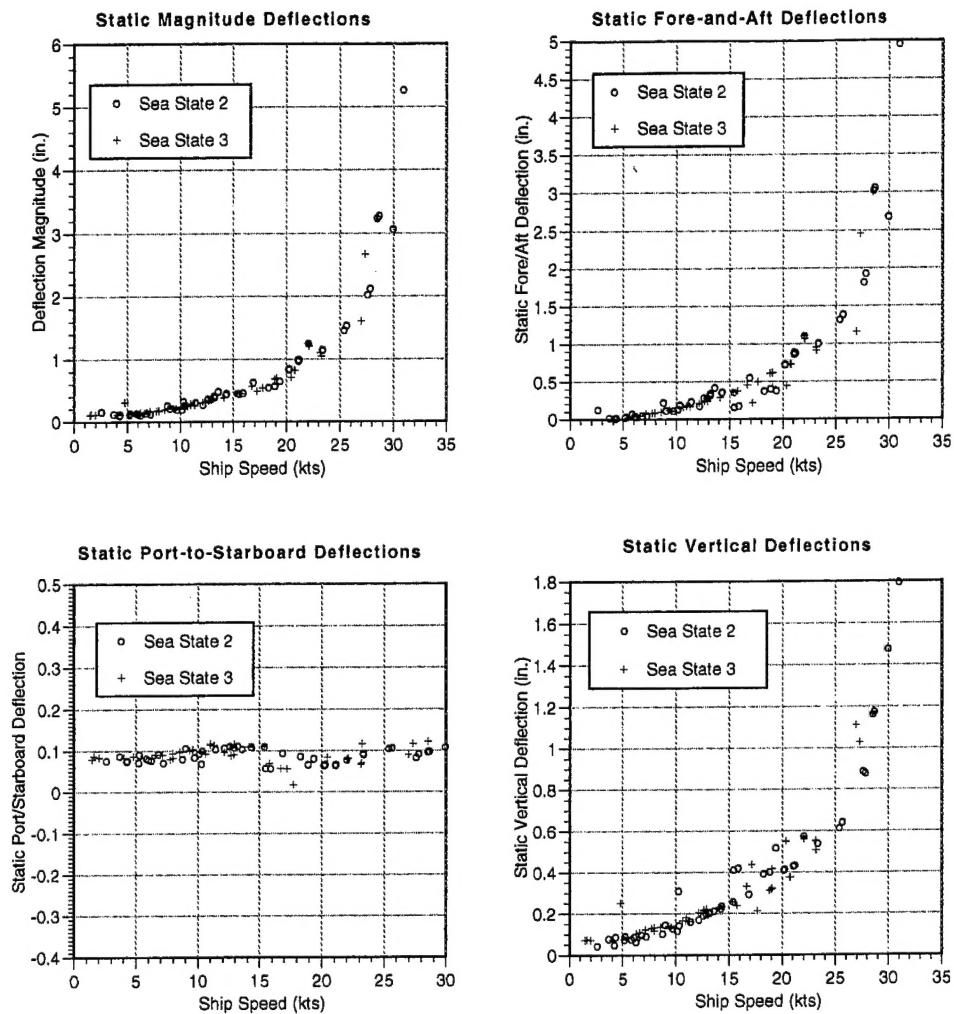
**Figure 4. USS Radford SDRW Static Deflections vs. Ship Speed  
(Linear Scale)**

(7) The magnitude of dome deflection is primarily determined by the force of the seaway. This can be seen in Figure 4, where data from 100 at-sea data sets are plotted as a function of ship speed and sea state.

(10) Figures 4 and 5 also show that, within the limited range of sea states measured, the deflection magnitude did not depend significantly on sea state.

The magnitude of dome deflection is primarily determined by the force of the seaway. This can be seen in **Figure 4**, where data from 100 at-sea data sets are plotted as a function of ship speed and sea state. The exponential nature of the deformation vs. ship speed is clearly visible when this data is replotted on Log/linear scale, as in **Figure 5**. A numerical fit to **Figure 5** is:

the sonar dome also increases exponentially. **Figures 4 and 5** also show that, within the limited range of sea states measured, the deflection magnitude did not depend significantly on sea state. This was a somewhat surprising result, as it was originally thought that higher sea states would result in added ship motions, which would produce additional dome oscillations. However, the lack of any real difference between the data for sea states 2 and 3 could be due to the limited range of sea states measured. Although some measurements were made at sea states 1 and 4, there were not enough to be statistically relevant in the plots of the above figures. It is unfortunate that the ship avoided heavier seas during these tests.

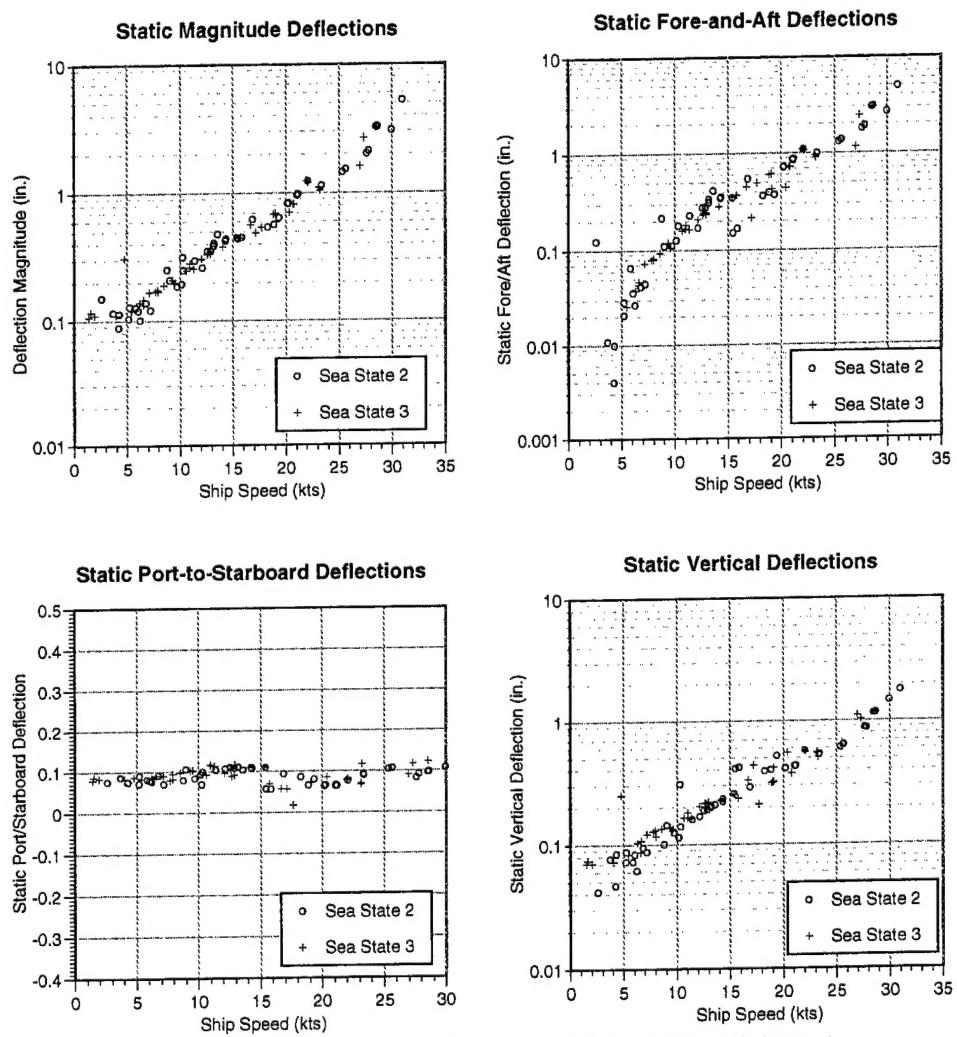
**Figure 5. USS Radford SDRW Static Deflections vs. Ship Speed  
(Log/Linear Scale)**

(8) The exponential nature of the deformation vs. ship speed is clearly visible when this data is re-plotted on Log/linear scale, as in Figure 5. A numerical fit to Figure 5 is:

(9) Figure 5 (and the numerical relationship above) shows that the magnitude of the deformation doubles approximately every 5 knots. The implications of this relationship imply that at high ship speeds the structural strain inside the sonar dome increases exponentially.

**Figure 5** (and the numerical relationship above) shows that the magnitude of the deformation doubles approximately every 5 knots. The implications of this relationship imply that at high ship speeds the structural strain inside

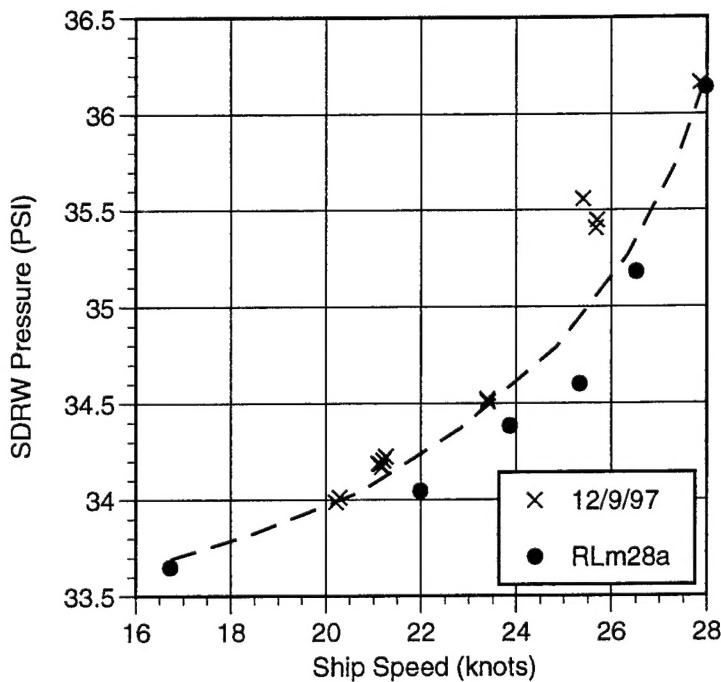
**Figure 6. USS Radford SDRW Static Pressure vs. Ship Speed**

(11) An increase in ship speed increases the dome internal pressure (nominally 0.25 PSI per knot), best seen in the data from the single data record Rlm28a during which the ship speed changed from 15 to 28 knots. Figure 6 shows this record as well as the average dome pressure for several other data runs.

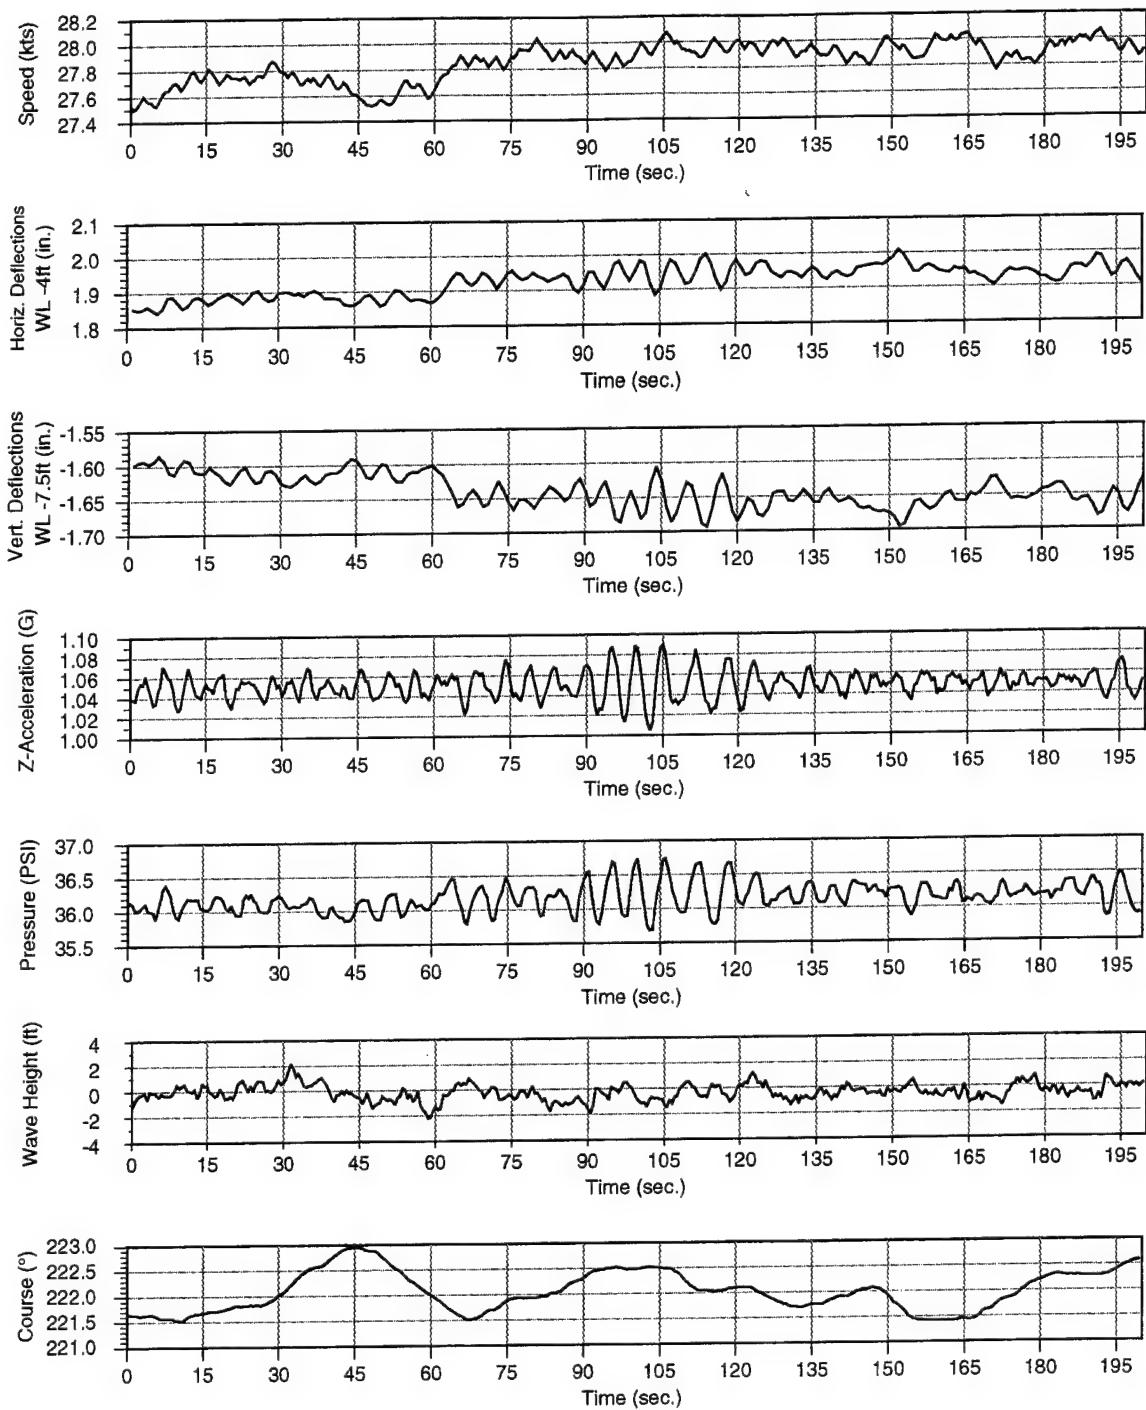
**Figure 7. Sample Data**

(12) In examining the environmental parameters for correlation to dome deformation, the greatest effect (besides ship speed) appears to be caused by the vertical acceleration of the ship. The vertical motion of the ship causes oscillatory dome deformations, which also cause internal dome pressure fluctuations. Figure 7 shows a sample set (data run RL28a) of some of the environmental parameters measured during each data run.

Data run RL28a was selected for Figure 7 because it optimally displays two different features of the environmental data. These two features are: (a) effects caused by significant speed changes, and (b) dynamic effects caused by other ship motions, such as roll, pitch, etc.

When the ship speed changes appreciably during a data run usually the change in dome deformation (and the other significant environmental parameters) is so large that the dynamic fluctuations are obscured by the scaling of the speed change effect. In RL28a the ship only increased speed by approximately 0.5 knot after the first 60 seconds of the data run. This speed change produces a noticeable increase in the horizontal deflection curve and an increased downwards (i.e. more negative) vertical deflection. Also noticeable is a slight increase, by approximately 0.25 PSI, in the average pressure. Thus, this data run is particularly interesting in that, the speed change is just large enough to demonstrate its influence on the other parameters, but without obscuring the dynamic aspects of the data independent of ship speed.

The dynamic effects are still clearly discernible in Figure 7 and show the correlation between vertical (i.e. Z) acceleration, pressure, and the horizontal and vertical deflections. This is most apparent in the time interval between 90 and 120 seconds where the largest dynamic oscillations occur. Notice that there is no visible correlation between the above parameters and the dynamic parts of the wave height, ship speed, and ship course data.

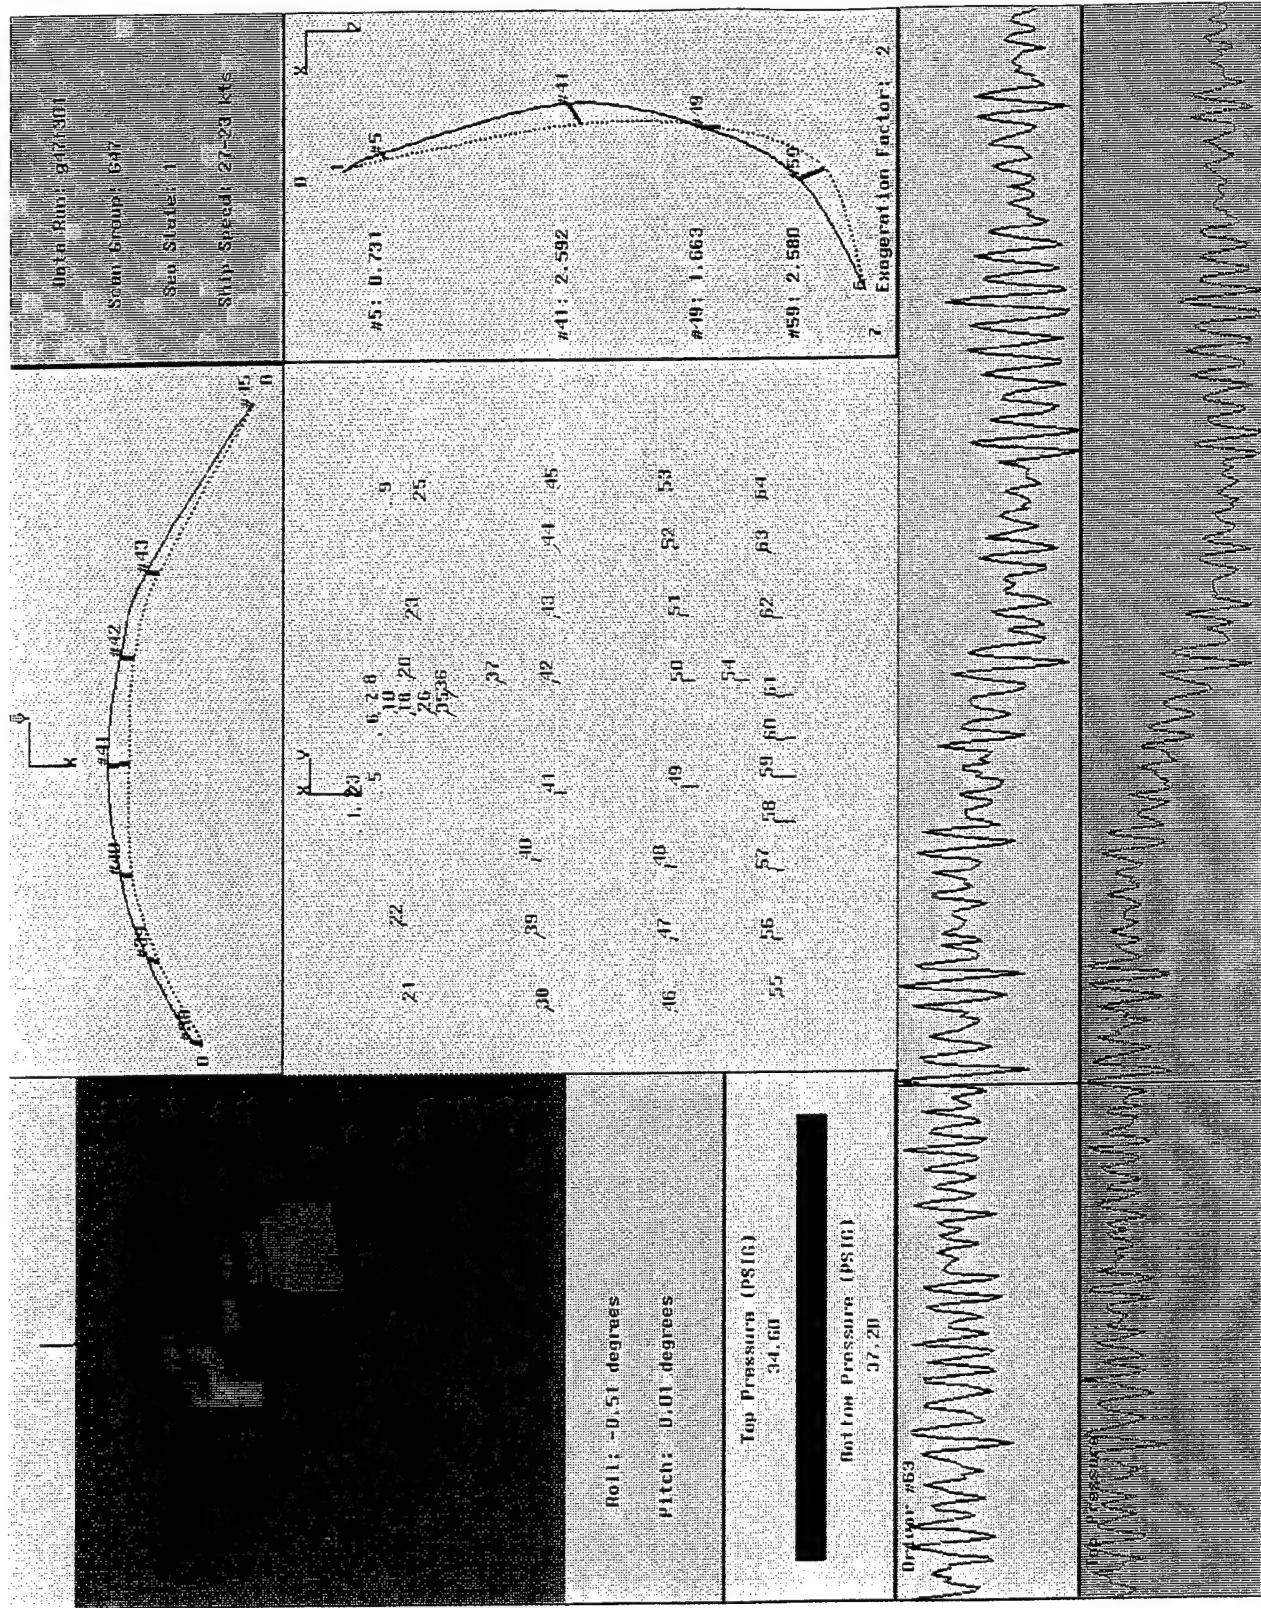
Figure 12: Sonar Dome Deflection Animation from USS Yorktown data, Jul-Aug, 1989.

display of environmental data (**Figure 7**) with the frame from the previous animation for the USS Yorktown sonar dome shown in **Figure 12**. While both show the same general deformation (i.e. the upper part of the dome bulges in and down, the lower part bulges out and down, and the sides of the dome bulge out and slightly upwards), the improvement in surface coverage, resolution, and in the range of environment parameters is dramatic.
